# Seismic Behaviour of Point Fixed Glass Façade Systems: State of the Art Review

*facade systems, point fixed glass systems, structural glass, seismic action*

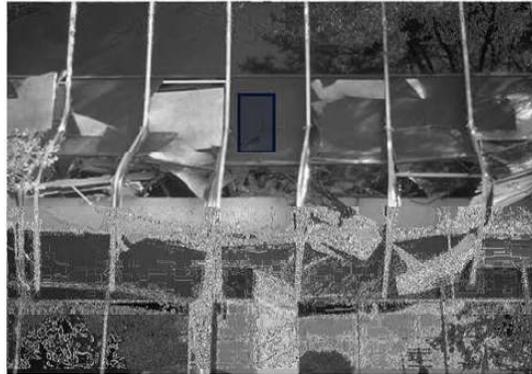
Fig. 1. Kaiser Permanente Building, Granada Hills, California, cladding offset [6].

buildings, an increasing interest rise about controlling their possible damage. An example of curtain glazing falling out is shown in figure 1.

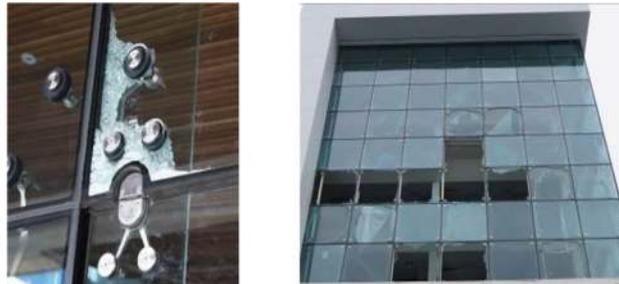
Fig. 2. Examples of damage to spider glazing systems on buildings [10].

A damage extent report of the Christchurch earthquake in 2011 (New Zealand,) showed that heavy damage was observed in spider glazing [10], as can be seen in figure 2, this behaviour was originated around the “spider” that holds each glass pane, likely a result of the “spider” creating stress concentrations in these regions due to the restraint of the connection to the structure. In table 1 is presented a resume of percentage of glass damage per seismic event for some of the significant earthquake events of the past 50 years, in figure 3 a chart with the data from table 1 is shown.

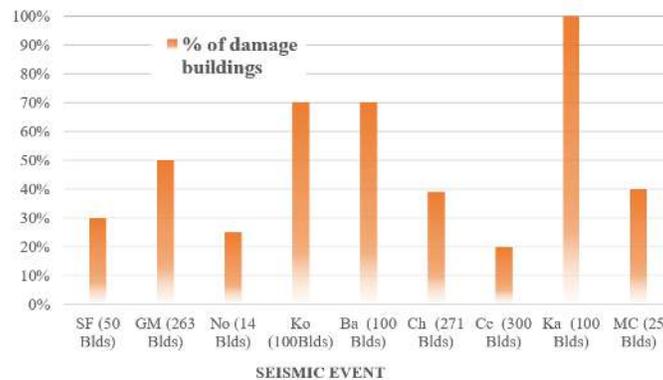
Fig. 3. Percentage of damage per major seismic event listed on table 1.

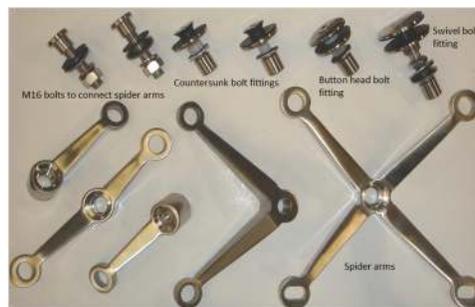
Fig. 4. Spider arms and bolt fittings for the PFGFS connections [16].

Bolted fixings provide point support to the glass panels and transfer the glass self-weight and lateral loads to the structural support. The bolted fixings are usually located towards the corners of the glass panels and additionally at intermediate points on long edges. Several types of bolts exist: enhanced countersunk fixings (allow to transfer out of plane and in plane loads directly through to the bolt and glass interface), articulated bolts fixings (allow for accommodate rotation of the fixing to glaze support), different type of spider arms and bolt fittings are shown in figure 4. All hardware is made of high quality mirror polished stainless steel (graded 304, 316, 316LM), ensuring best possible protection against oxidation and corrosion. Principal elements of a spider arms fixing are shown in figure 5.

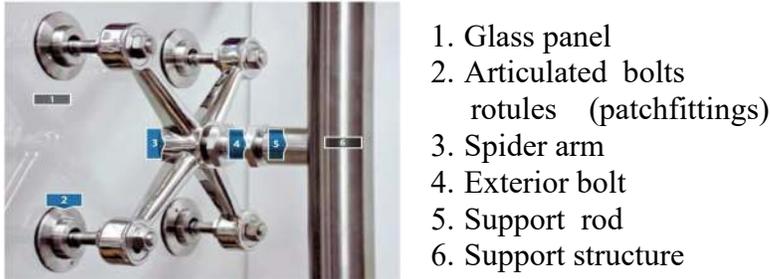
Fig. 5. Glass façade spider arms components [17].

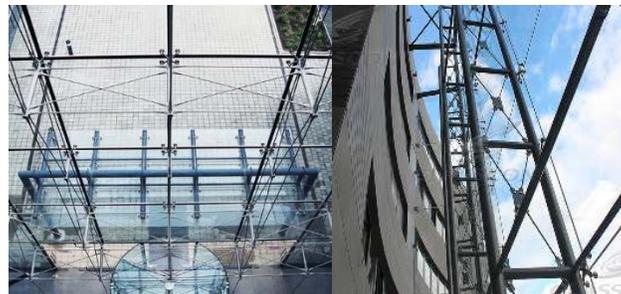
Fig. 7. Examples of façade support structures from GLASSCON Projects (from web site [18]).  
Analytical and Experimental Studies for PFGFS

The main job of the support structure is to transfer loads from the glazing support attachments to the building structure itself, as well as for the glazing support attachments, support structures may be different according to the architectural requirements, but two of the most common systems are steelwork structures (trusses and fins) and cable systems (rod or wires working under tension loads), figure 7 shows examples of those systems.

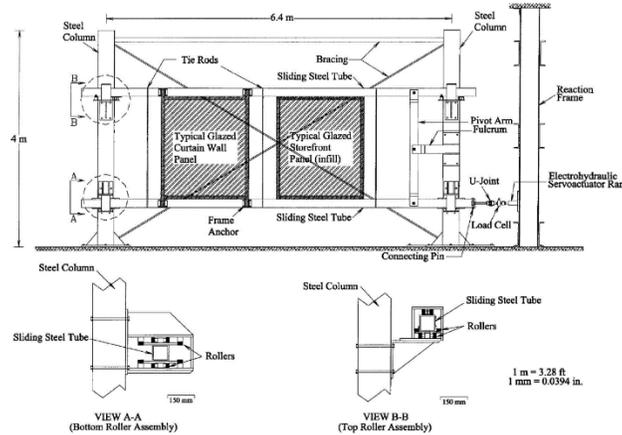
Fig. 8. Dynamic Racking Test facility at the Building Envelope Research Laboratory Department of architectural Engineering, The Pennsylvania State University [23].

Experimental and analytical studies have been performed over the past 30 years for seismic performance of framed glass façade systems, focusing on their behaviour after mayor earthquakes ([12]; [20]; [21]; [22]). One of the most significant experimental work on this topic developed at the Building Envelope Research Laboratory of the University of Missouri-Rolla (UMR), investigating the serviceability and fallout resistance of popular curtain wall systems used on mid-rise buildings under simulated earthquake [23]. Figure 8 shows the test set-up used for the testing program at UMR.

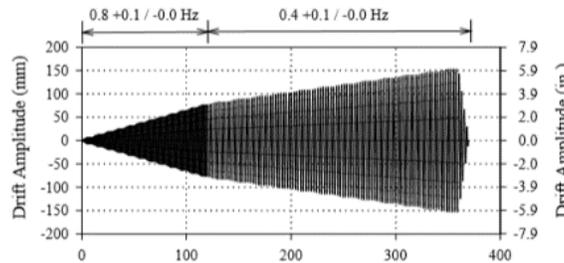
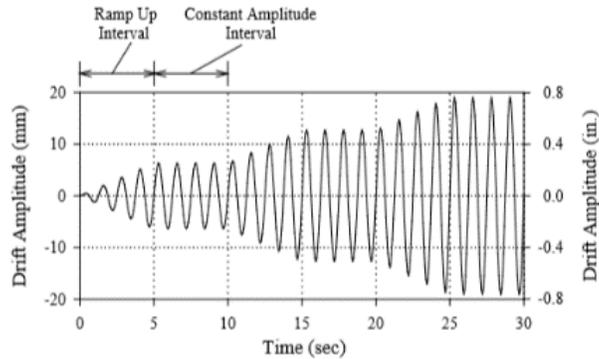
a) for full time load

b) for the first 30 seconds of time.

Fig. 9. Crescendo load path for dynamic test.

The so called “crescendo tests” were performed by means of hydraulic controlled actuators increasing lateral displacement to glazed systems, figure 9 shows the sinusoidal progressively increasing racking amplitudes. Those experimental studies lead to a number of recommended revisions, namely: “NEHRP Recommended Provisions for the Seismic Regulations for New Buildings and Other Structures (FEMA 450)” which were published in the 2000 NEHRP Provisions FEMA 451 [45]. The experimental work layout allowed to develop industry-accepted test protocols published by the American Architectural Manufacturers Association (AAMA) as: “Recommended dynamic test method for determining the seismic drift causing glass fallout from a wall system” published on AAMA 501.6 in 2001 ([24]; [25]; [26]).

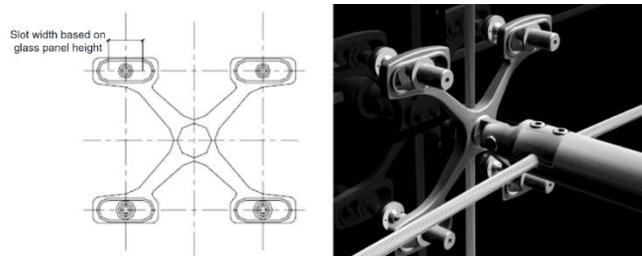
Fig. 10. Spider arms with horizontally slotted holes [31].

In order to improve the behaviour of PFGFS in areas of high seismicity, the seismic performance of specially design spider arm systems connecting the glass to structural support frames was assessed [31]-[32], including large horizontally slotted holes allowing isolated horizontal translation (figure 10), for that purpose, special low modulus silicon sealant was used to allow rigid body translation during the racking actions. The sizes of the slotted holes need to be calculated according to the glass façade drift demands from the building. During the experimental test [30], the façade frame was subjected to in-plane displacement in incremental magnitudes of three cycles of elastic drift condition (0.4%), one cycle of inelastic drift condition (2.5%) and a third drift capacity of (2.9%). The system behaved very well, accomplishing all code criteria with glass panels remaining intact, only when the frame was racked beyond the design range of the spider slots the glass panels showed noticeable rotation but no glass nor bolt failure were observed.

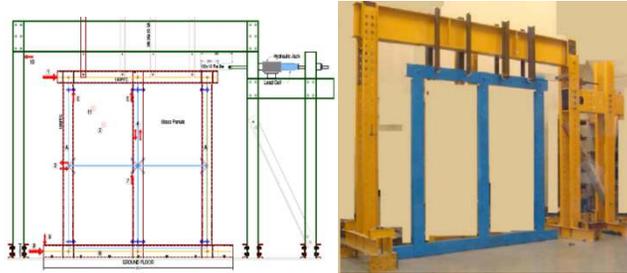
Fig. 11. Structural support frame for reaction frame and location of LVDTs and hydraulic jack [33].

countersunk bolt fittings for laminated glass panels joined with silicon weather sealant, b) K-type spider arms and button head bolt fittings. Both tests were subjected to 100kN in-plane lateral load and more than 150mm in plane displacement, figure 11 shows the test layout.

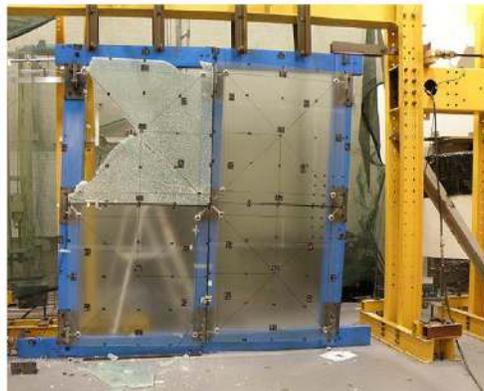
Fig. 12. The PFGFS after failure of a glass panel (Test #2)) [30].

Two tests were completed, PFGFS with pinned X-type (test #1) and fixed K-type spider arms (test #2), results showed that the systems had large in-plane drift capacities due to a rigid body translation [16]-[34], 2.1% of lateral drift ratio for the test #1 and 5.25% for test #2. Larger drift capacity was associated with three main mechanisms: built-in standard gaps between the bolts and holes within the spider arm and structural support frame connections, possibility of the In-plane rigid-body rotation of the spider arms and deformations and yielding of the spider arms allowing the system to move laterally. Failure occurred when out-of-plane movement induced by combined local bending and diagonal tensile stresses around spider arm bolted connections, lead to initiation of cracking in one of the glass panels (figure 12).
